Archaeological and Biological Examination of the Rib Wreck (8MO1880) off Vaca Key, Monroe County, Florida

A Report by the Florida Underwater Archaeology Team, Bureau of Archaeological Research, Division of Historical Resources, Department of State

December 2007

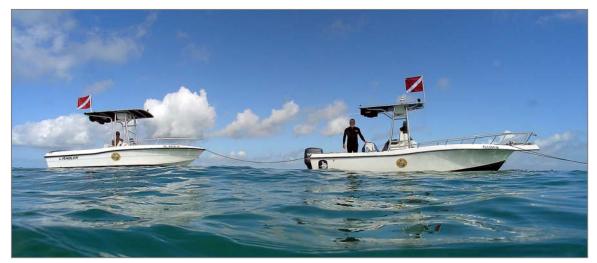
Figure 3. State vessels on site.

Each day R/V *Workhorse* (21-ft. Offshore) and R/V *Scout* (18-ft. Angler) traveled in company to the location of the Rib Wreck site and moored to a temporary buoy attached to a Danforth[®] anchor installed for the project (Fig. 3). Diving operations

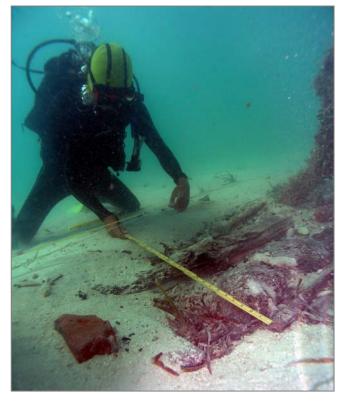
Figure 4. Archaeologist measuring Section I at baseline.

Archaeologists laid a baseline along the centerline of the vessel. This method remains as the primary tool for documenting structural elements and orienting archaeological divers to certain areas of the shipwreck site. The baseline, laid with nylon line, measured 100 ft. in length and was tied to iron rebar stakes placed along the south side of the protruding ribs. The stakes established two datum points: 'A' to the northeast and 'B' to the southwest. A 100-ft. reel tape was secured to it. The zero point of the baseline tape was established east of the first frame but within the scatter of material

frames, and other material was produced (p. 10). Detailed feature drawings of the exposed timbers in two separate areas, Sections I and II, were also made.

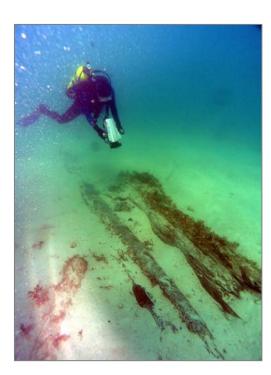
Figure 5. Diver video recording; keelson, sister keelson, and pipe in view.

Otherwise, only portions of the wreck that were exposed above the sand were recorded. Large keelson and potential sister keelson or planking timbers run along the axis of the site and are partially exposed over a length of 80 ft. (Fig. 5). The molded height of the keelson is undetermined with sided thickness я approximately 1 ft. but generally worm eaten and deteriorated by exposure to the elements. The southern terminus of the keelson has two sets of four bolts protruding. The molded height of the potential sister keelson is undetermined; its sided thickness is approximately .70 ft.

Three pipes were recorded and mapped at the site. One pipe measures 7.5 ft. in length and .5 ft. diameter (Fig. 5). The other two pipes are identical to each other and lie partially buried in the sand near the northeast terminus of the keelson remains (Fig. 8). The pipes are 6.7 ft. in length and tapered from .8 ft. to .4 ft. diameter in the last couple feet of their length. The two pipes are also reinforced with heavy bands at three points along their length.
